Capital Inspection Services

Property Inspection Report

1234 Swimming Lane, Fairfax, VA 22152
Inspection prepared for: Joe Swimmer & Joe Swimmer
Real Estate Agent: Linda DeFelice - Keller Williams

Date of Inspection: 4/15/2013 Time: 8:30 Am
Weather: cloudy

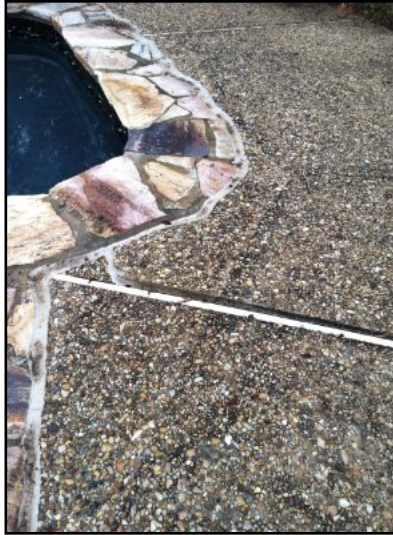
2. Deck Condition

Observations:
 • One section is raised and is a trip hazard.
 • Two low sections will hold water, addition of drains would be helpful.

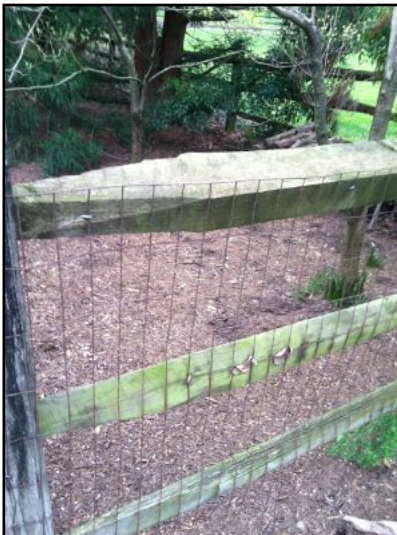
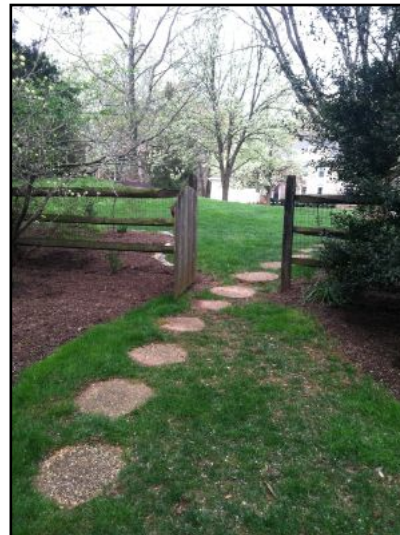
3. Gate & Fence Condition

Materials: Split rail with wire mesh.
 Observations:
 • Gate did not self latch.
 • Fence openings do not meet current building codes.

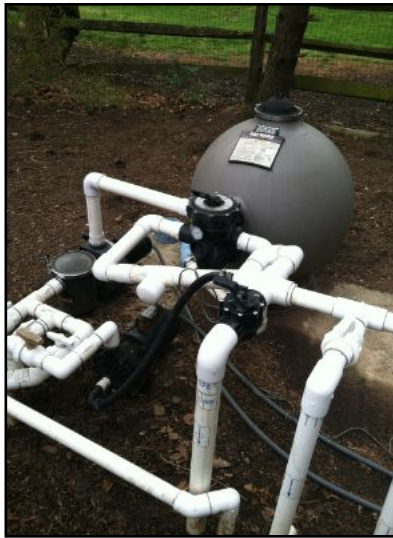
9. Pumps

Observations:
 • operated
